# Manhole Inspection Summary

Manhole # S19MM\_007MH

**Location** Address: **2220 MONROE ST**

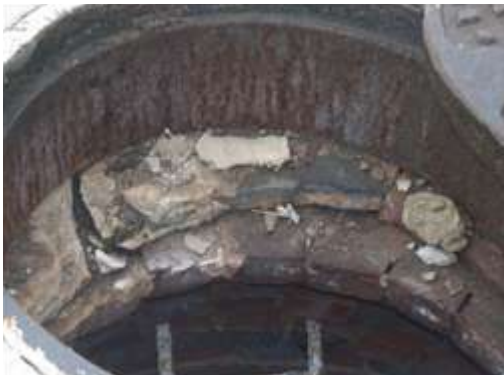
Defect 2

Condition: ☐ Sound ☐ Cracked ☐ Root Intrusion ☐ Loose Brick ☒ **Deteriorated**

DETERIORATION OF CHIMNEY

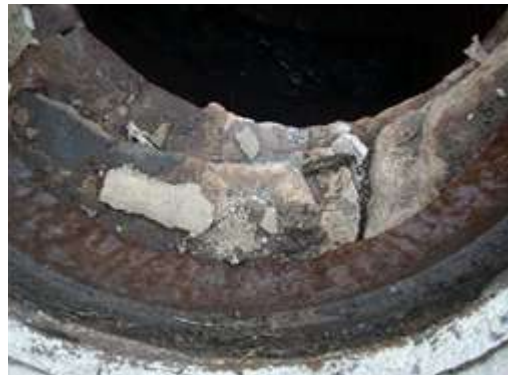
Defect 1

**Frame** Offset: **8** (in.) Condition: ☒ Sound ☐ Cracked ☐ Leaks

FRAME OFFSET

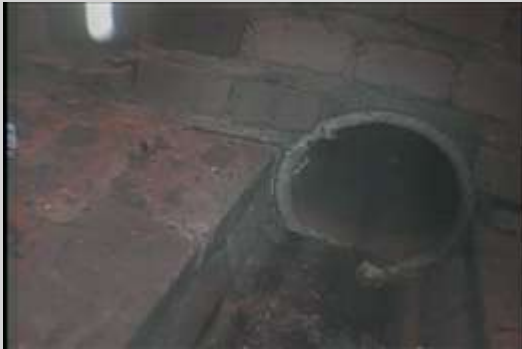
12 O'Clock Outflow

8 in. Circular Gravity Sewer  
Pipe Out @ 12 O'Clock

Pipe Height: **8.4** (in.) Rod and Bar (Angled)  
Pipe Material: **Clay** ☐ Pipe Lined  
Invert Depth: **6.99** (ft.) Flow Characteristics: **None**  
Deposits: ☒ None ☐ Mud ☐ Sludge ☐ Debris ☐ Grease  
Silt Depth: (in.) Deposits Extent:  
Infiltration: **None** Pipe Seal Cond: **Sound**

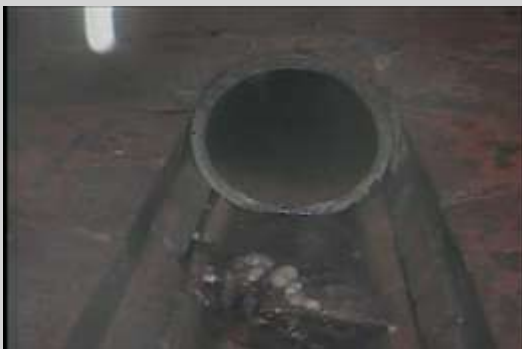
5 O'Clock Inflow

8 in. Circular Gravity Sewer  
Pipe In @ 5 O'Clock

Pipe Height: **8.4** (in.) Rod and Bar (Angled)  
Pipe Material: **Clay** ☐ Pipe Lined  
Invert Depth: **6.81** (ft.) Flow Characteristics: **None**  
Deposits: ☒ None ☐ Mud ☐ Sludge ☐ Debris ☐ Grease  
Silt Depth: (in.) Deposits Extent:  
Infiltration: **None** Pipe Seal Cond: **Sound**
